EVALUATION OF LUBRICANTS TO INCREASE WIRE ROPE LIFE

by Jack E. Fraley (1) and Grant L. Anderson (2)

ABSTRACT

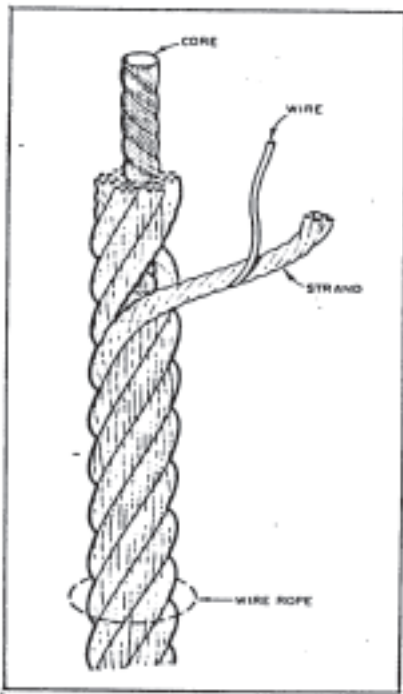
Figure 1 - Three parts of a wire rope.

The traditional method of evaluating lubricant effectiveness has been to Perform reveral laboratory tests 3 to compare desirable lubricant properties such as corrosion resistance, viscosity and adhesion. Wire rope consists of a core, strands, and wires (figure 1). As a rope is loaded during hoisting operation, the strands and wires rub against each other and against the core, which makes the rope behave as a machine with several moving parts. The laboratory test often do not evaluate a rope under load. Consequently, they are not able to deteriane the extension of rope life with proper lubricant usage.

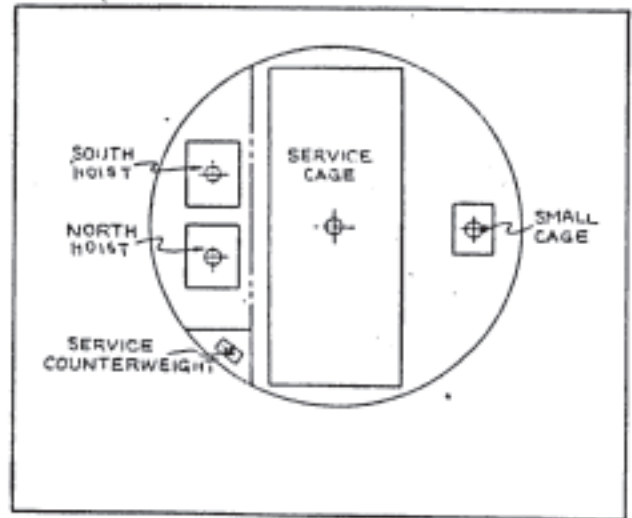
Figure 3 - Plan view of hoist ropes

One arrangement of hoist ropes in a molybdenum mine consists of five ropes: (1) the service cage rope, (2) the service cage counterweight rope, (3) the small cage rope, (4) the south waste hoist rope, and (5) the north waste hoist rope. All of these ropes were subjected to similar environmental conditions. A side view of the rope arrangement is shown in figure 2; a plan view is shown in fig 3.

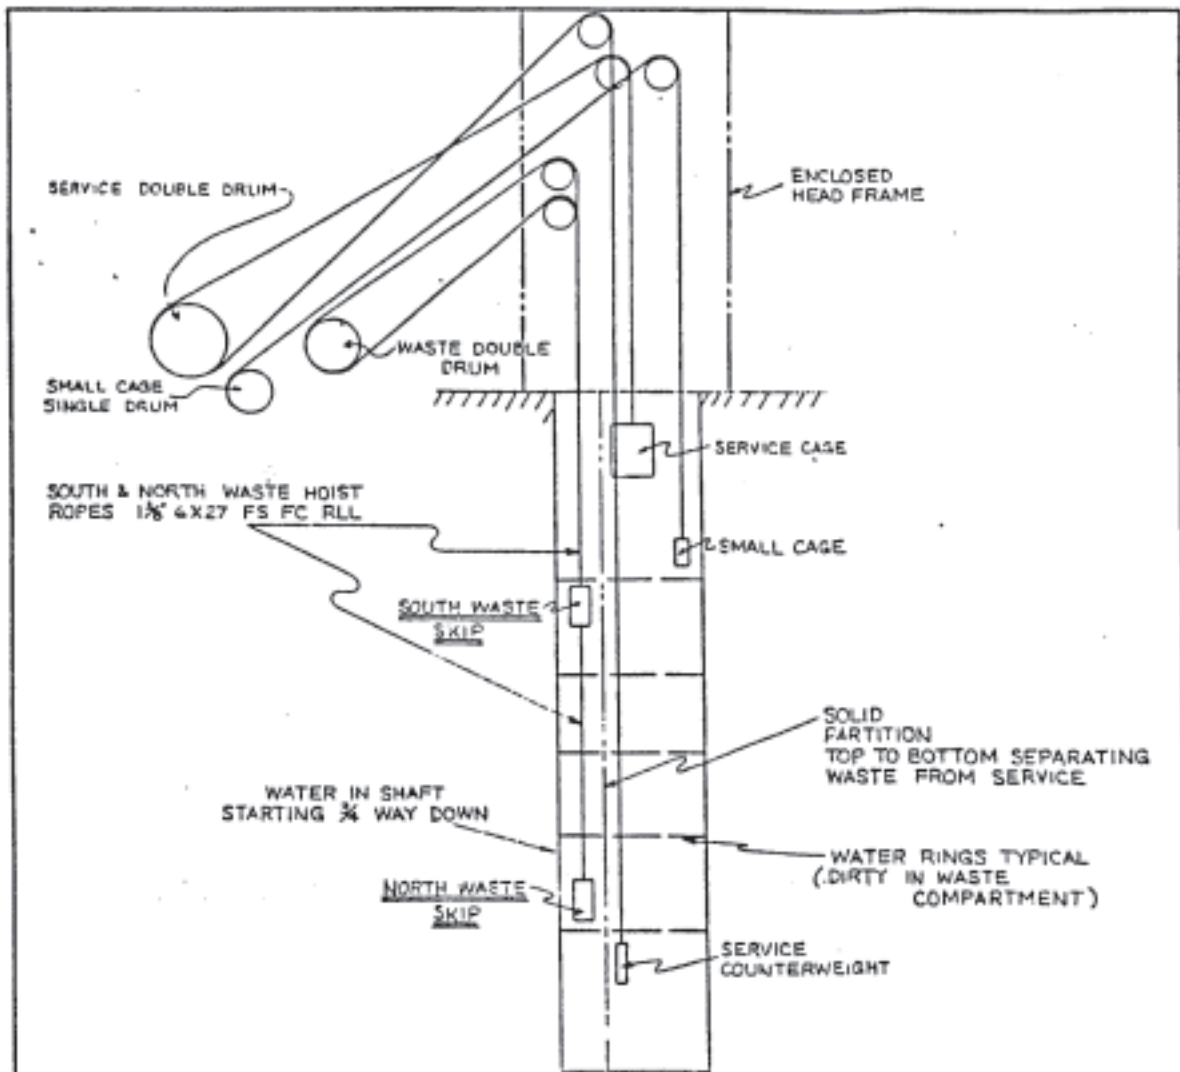
Figure 2 - Hoist rope arrangement

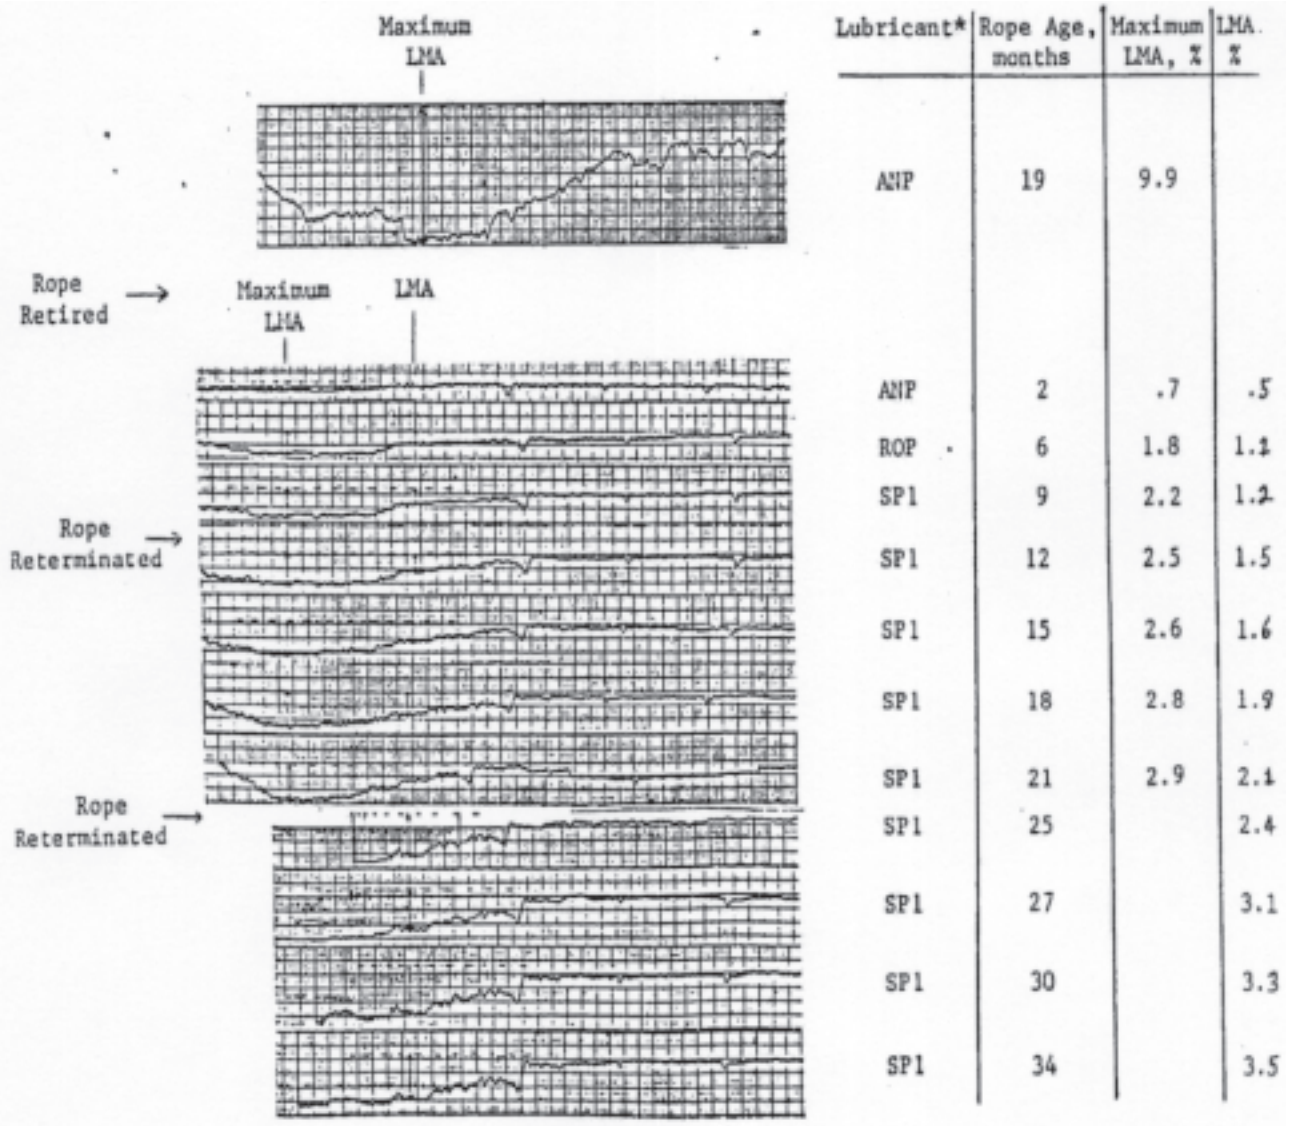
*ANP = Asphalt base, nonpenetrating.
 *ROP = Rice-oil base, thin, penetrating.
 *SP1 = Synthetic base, thin, penetrating.

Figure 4 - LMA strip charts for mine 1 south waste hoist ropes.

Figure 4 shows the LMA portions of the strip charts for the south waste hoist. The first LMA trace (separated from the others) is for a rope retired from service after 19 months; the other LMA traces are for the replacement rope. Two rope determinations are indicated. The second rope determination cut off the maximum LMA of the rope that was read from the strip charts, requiring that the LMA be read at a second chart location.

As figure 4 shows, the LMA increased as the replacement rope aged but at a much slower rate than for the retired rope. The lubricants are shown in figure 4 along with the rope age and the LMA.

The asphalt-bars, nonpenetrating lubricant performed poorly as evidenced by the rope retirement after only 19 months of service. The replacement rope had rice-oil-base, penetrating lubricant applied after 6 months of service and a synthetic penetrating lubricant applied thereafter. The extension of rope life is indicated by the much smaller LMA after 34 months than for the first rope after 19 months.

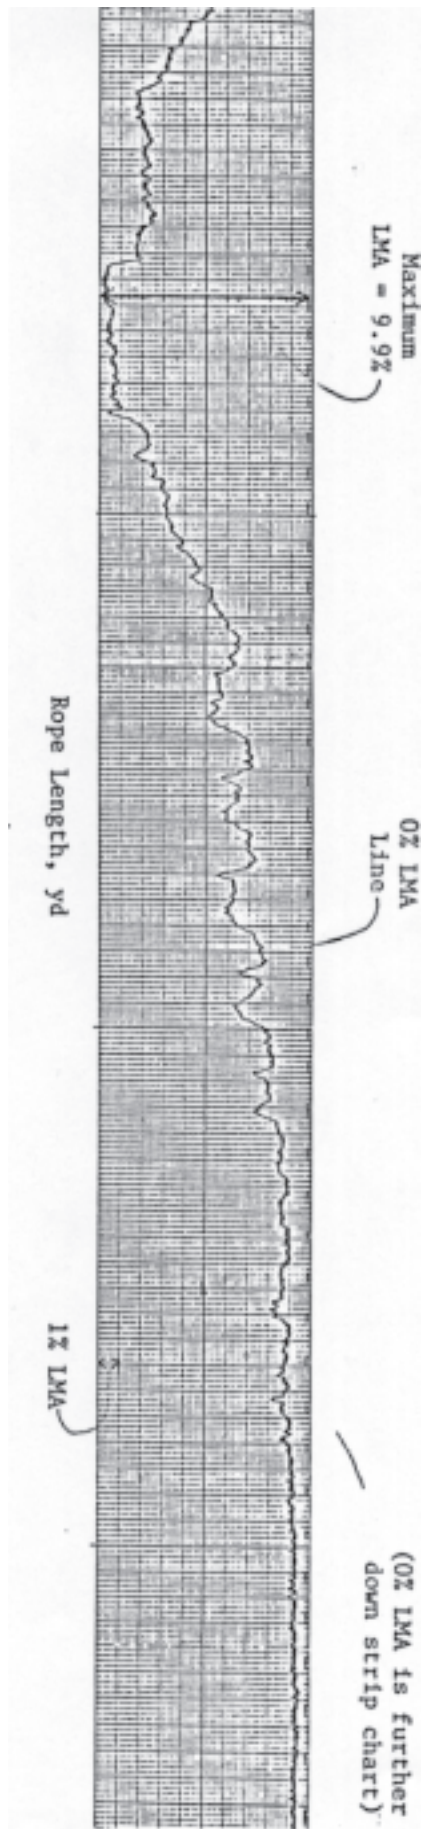
Figure 5 - How the LMA is read from the strip chart.

Figure 5 illustrates how the LMA is read from the strip charts. The uppermost portions of the LMA trace normally represent those sections of the rope with the least metal loss. The horizontal dotted line (0% LMA line) assumes that there is no metal loss from the best rope sections (which is not always the case). The NDT instrument is calibrated so that each of the 10 major vertical divisions on the strip chart represents a 1% LMA. The maximum LMA of 9.9% is obtained by counting the major vertical divisions between the 0% LMA Line and the lowest point on the LMA trace.

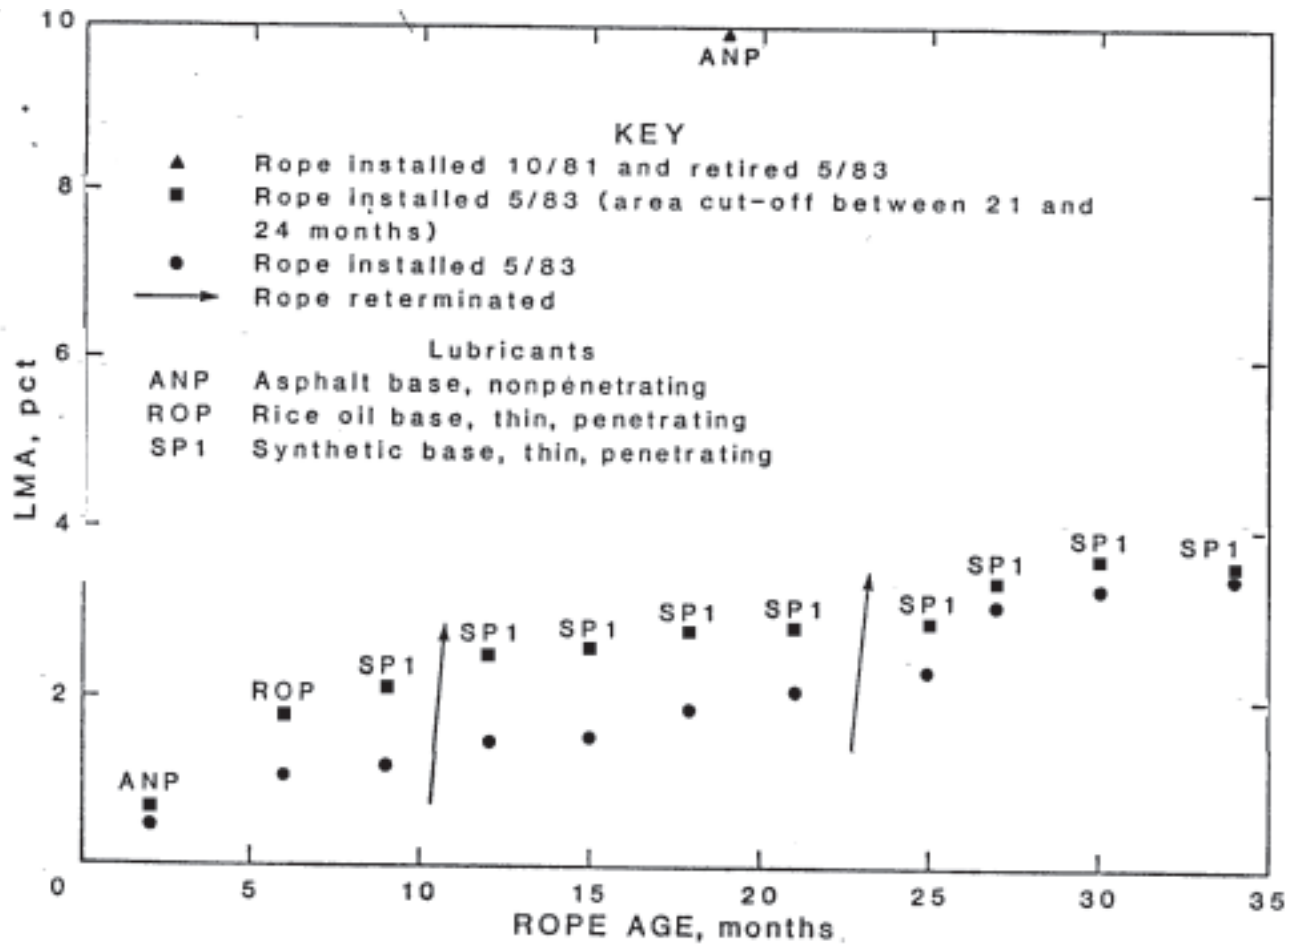
Figure 6 - LMA for mine 1 south waste hoist ropes.

Figure 6 shows a plot of the LMA versus rope age. The lubricants and rope reterminations are also indicated. Those LMA's shown as black squares (■) are the maximum LMA's on the rope before the area was cut off. Those LMA's shown as black circles (●) are at the same point on the rope past the reterminated section. The retermination before the 25 month test placed the remaining rope closer to the skip; this increased the rate of LMA because the skip descends into an environment that promotes greater internal corrosion.

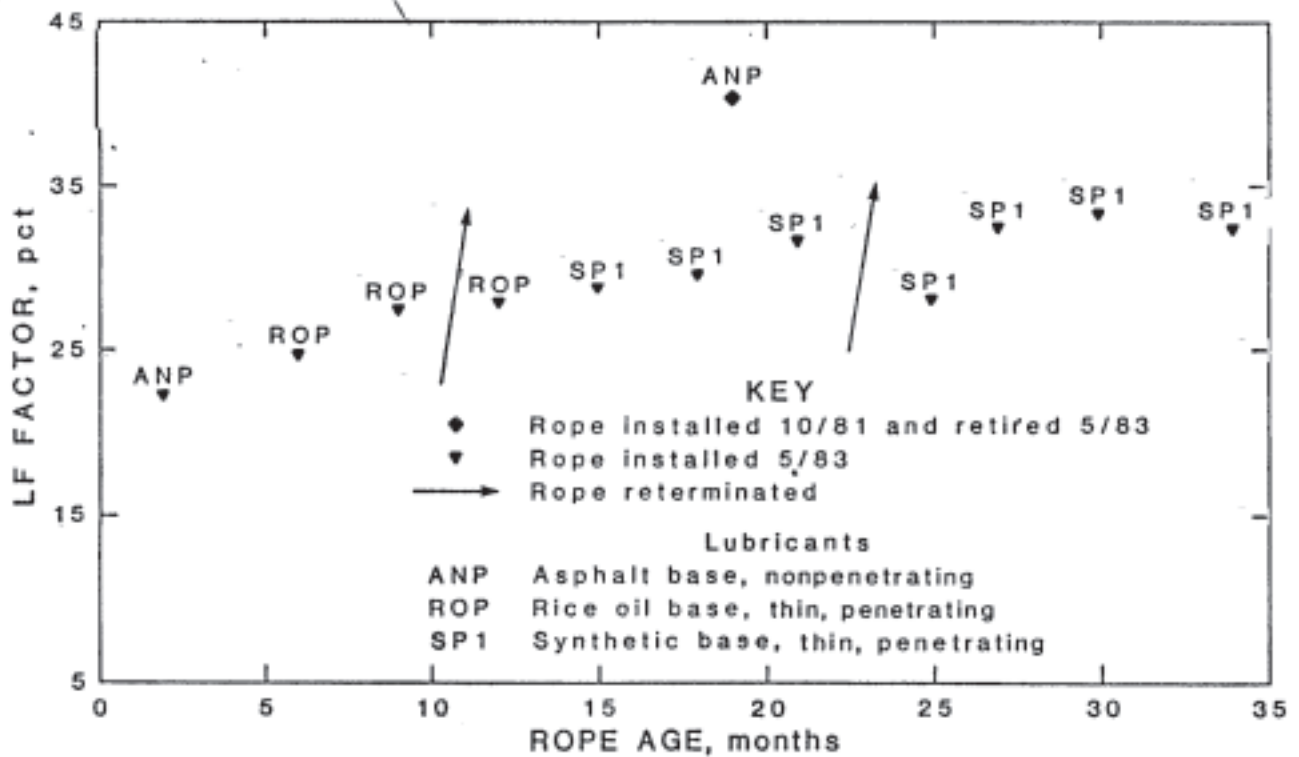
Figure 8 - LF factors for mine 1 south waste hoist ropes.

Figure 8 shows a plot of the LF factor versus age. The first rope had a larger LF factor due to its greater internal corrosion. As the replacement rope aged, its LF factor increased.

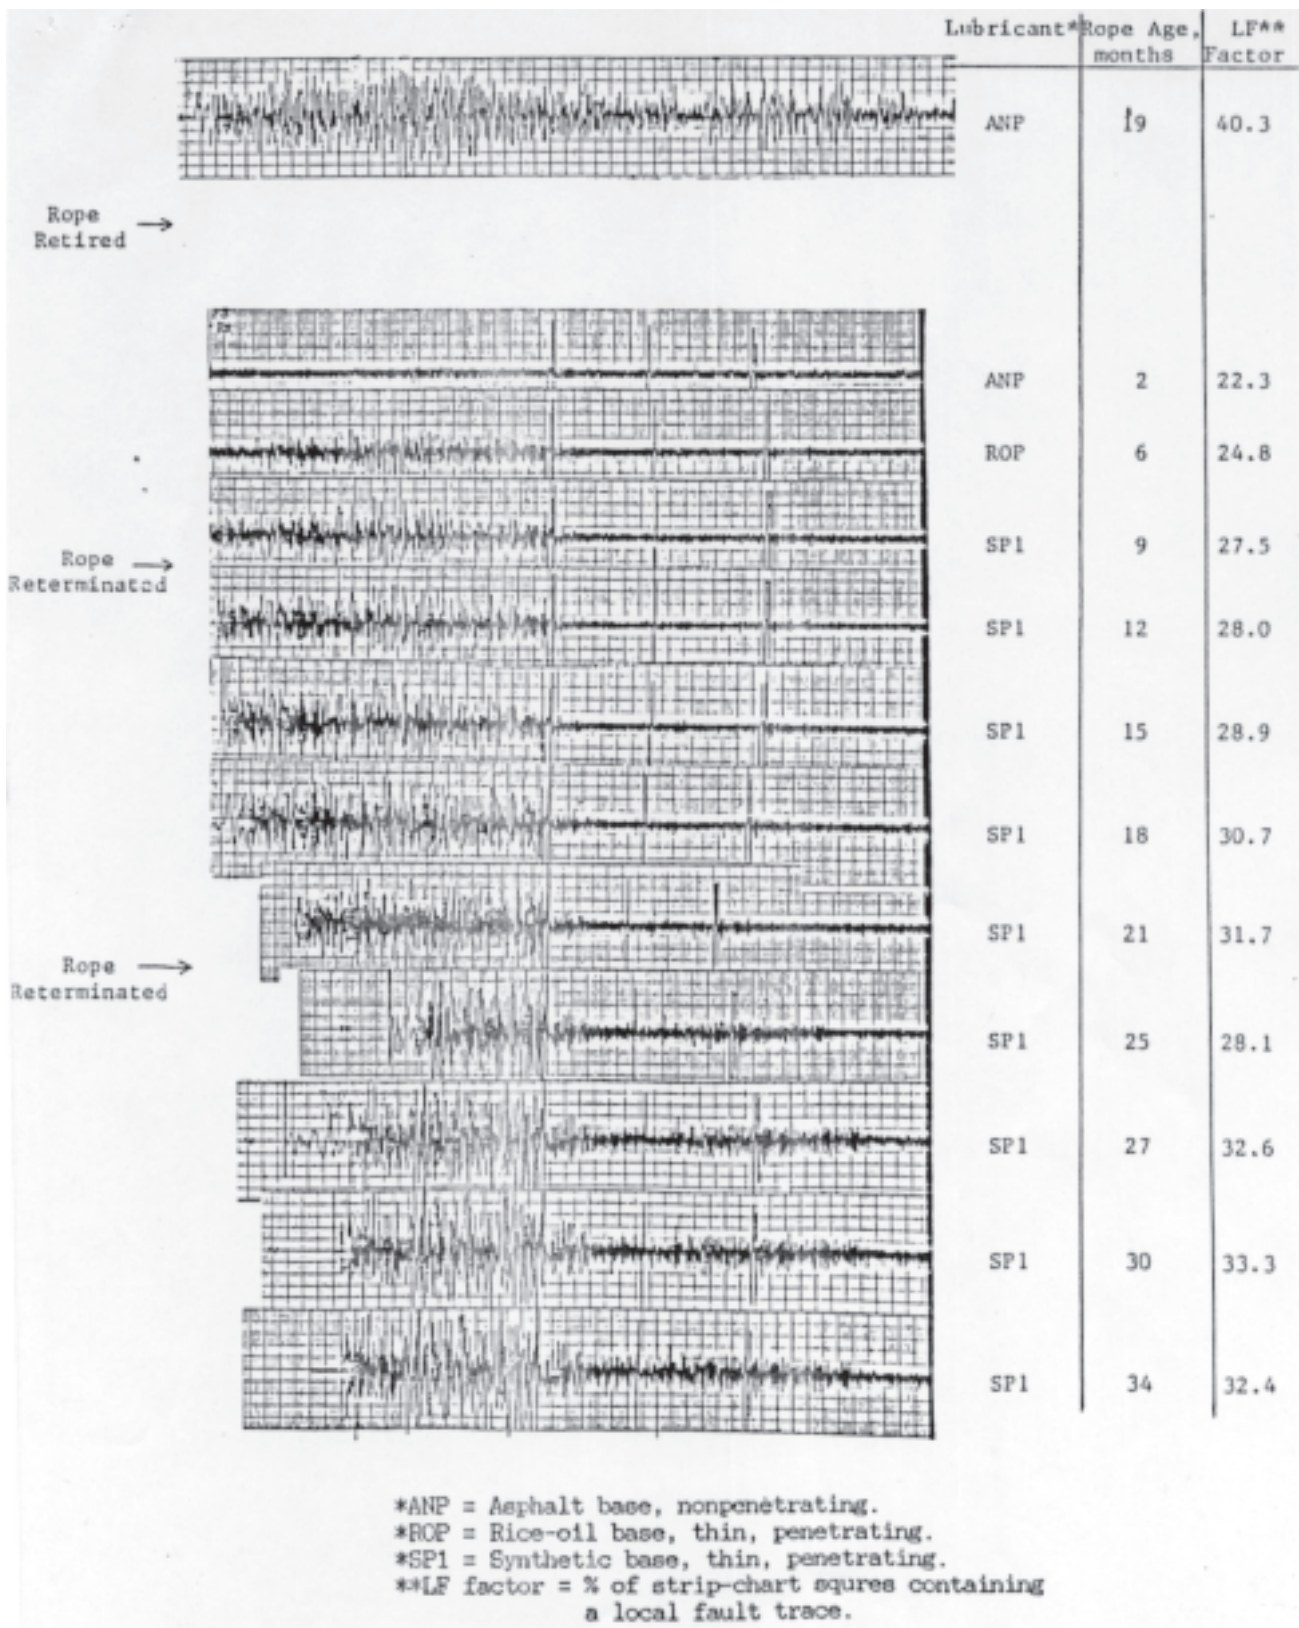
Figure 7 - LF strip charts for mine 1 souyh waste hoist ropes.

Figure 7 shows the LF portion of the strip charts for the south waste ropes. The charts show that, due to more internal corrosion, the vertical widths of the traces are greater in those areas where the LMA's are larger. Also shown is the rope age and "LF factor." The LF factor is the percentage of total strip chart squares that contain at least one LF trace. As the rope ages, the LF factor will increase as the rope degrades. A smaller LF factor with increasing rope age as shown at 25 months (figure 7) is the result of slight variations in instrument calibration.

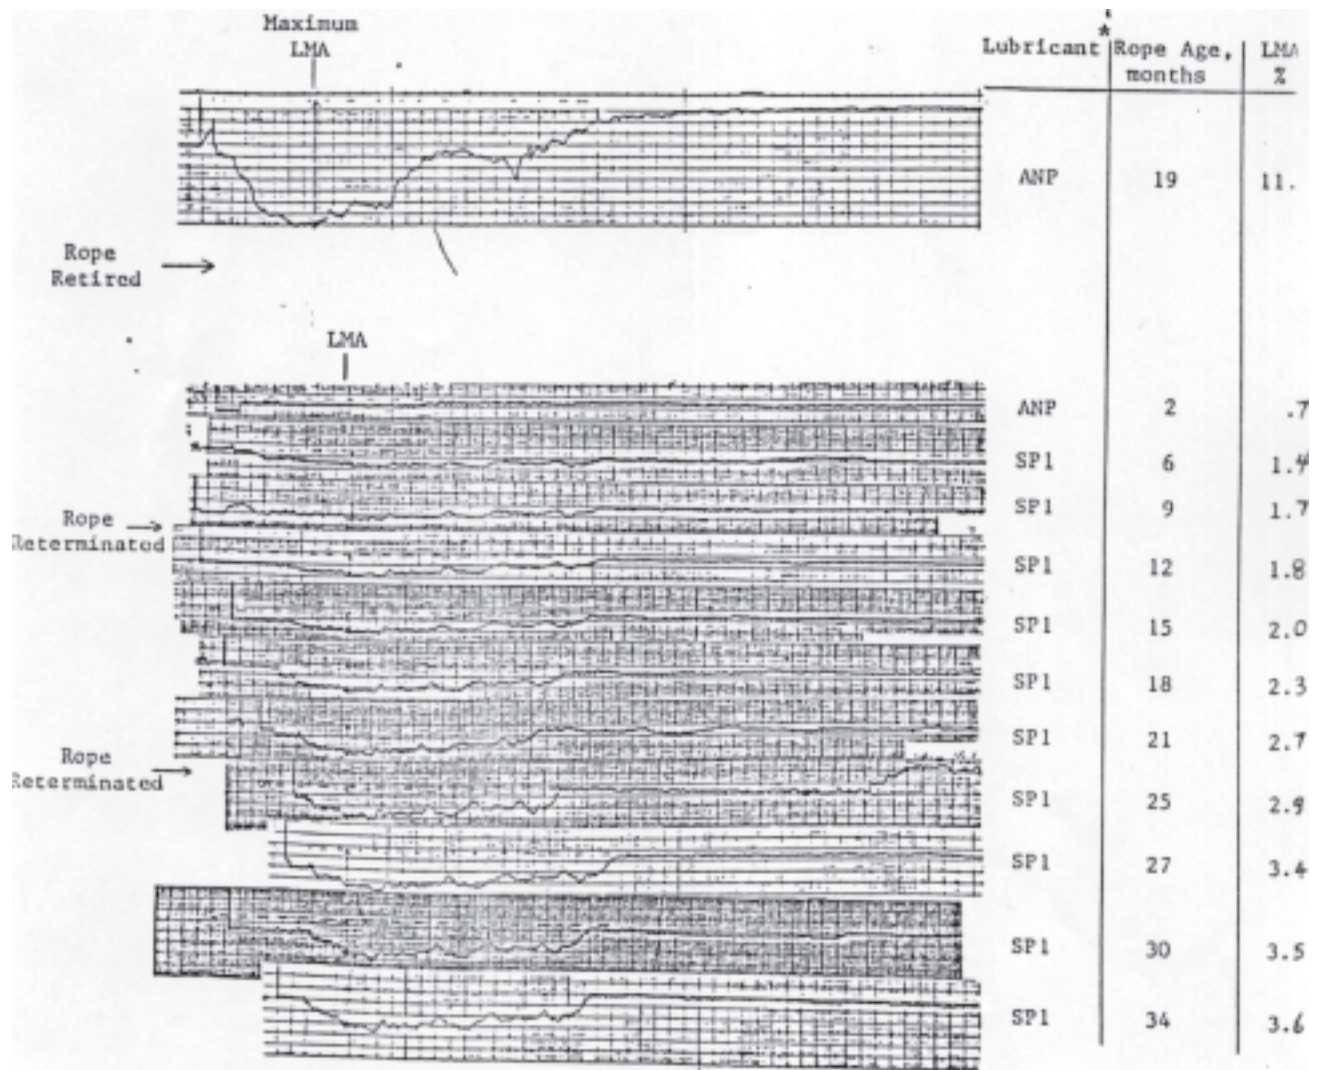
*ANP = Asphalt base, nonpenetrating.
 *SP1 = Synthetic base, thin, penetrating.

Figure 9 - LMA strip charts for mine 1 north waste hoist ropes.

Figure 9 shows the UIA traces for the north waste hoist ropes. The information is similar to that for the south waste ropes because both hoists are side by side and had similar lubricants applied. The first rope, again, showed a greater LMA after 19 months than did the replacement rope after 34 months. The asphalt-base, nonpenetrating lubricant on the first rope did not reduce internal corrosion.

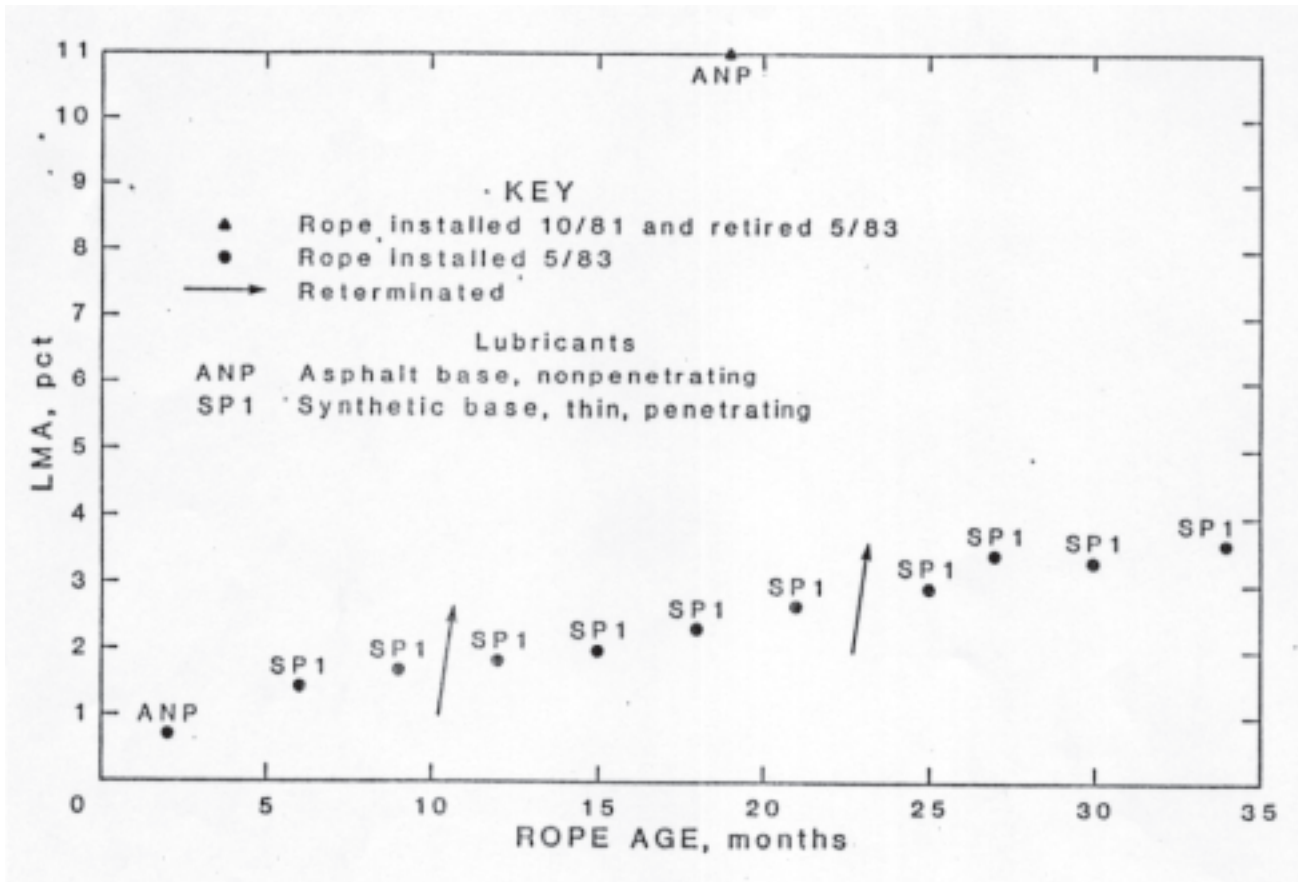
Figure 10 - LMA for mine 1 north waste hoist ropes.

Figure 10 shows the LMA for the north waste hoist rope versus the rope age. As the rope aged, the LMA increased; however, the synthetic-base, thin, penetrating lubricant slowed the growth of internal corrosion more than did the asphalt-base lubricant.

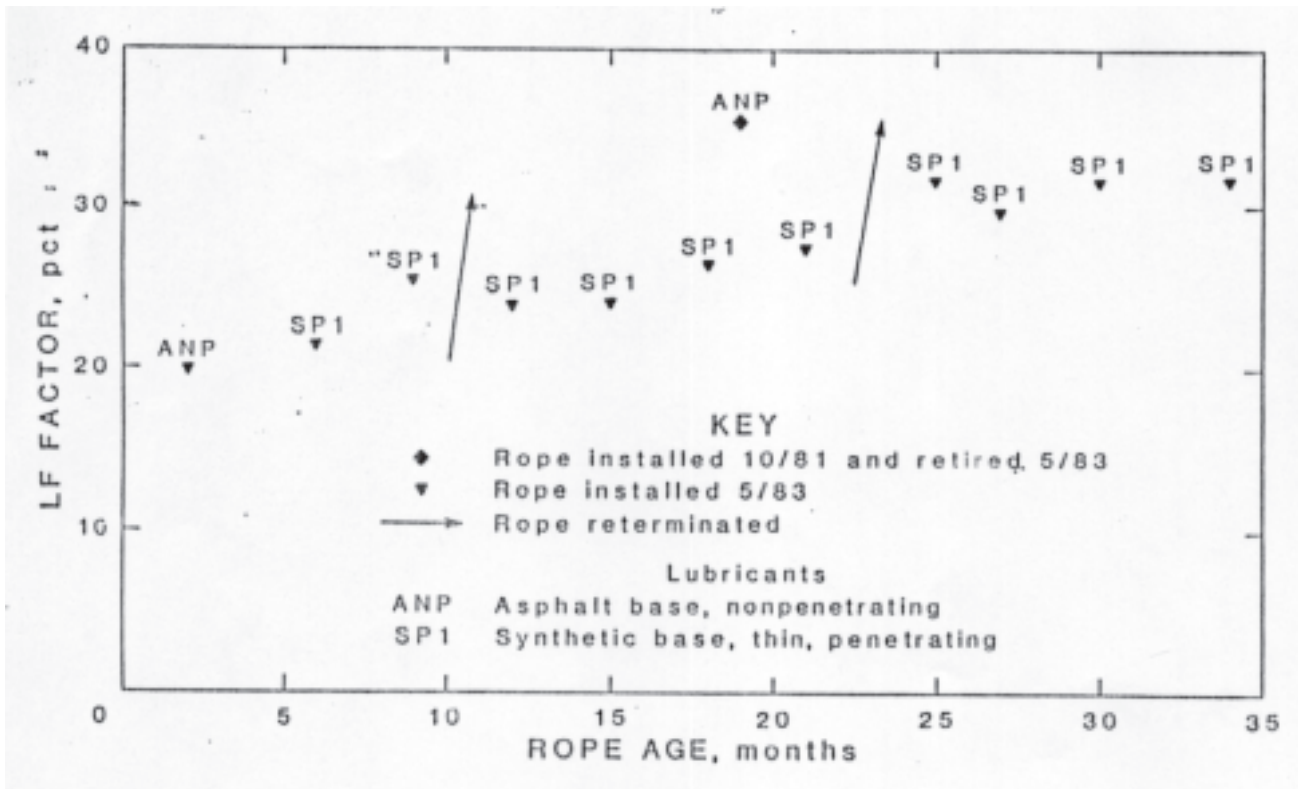
Figure 12 - LF factors for mine 1 north waste hoist ropes.

Figure 11 shows the LF strip charts for the north waste hoist ropes. As before, the vertical height of the LF trace is greater in those areas that have more internal corrosion. The smaller LF factor with increasing rope age is caused by variations in instrument calibration. Figure 12 shows the larger LF factor for the first rope and the LF factor growth as the replacement rope ages.

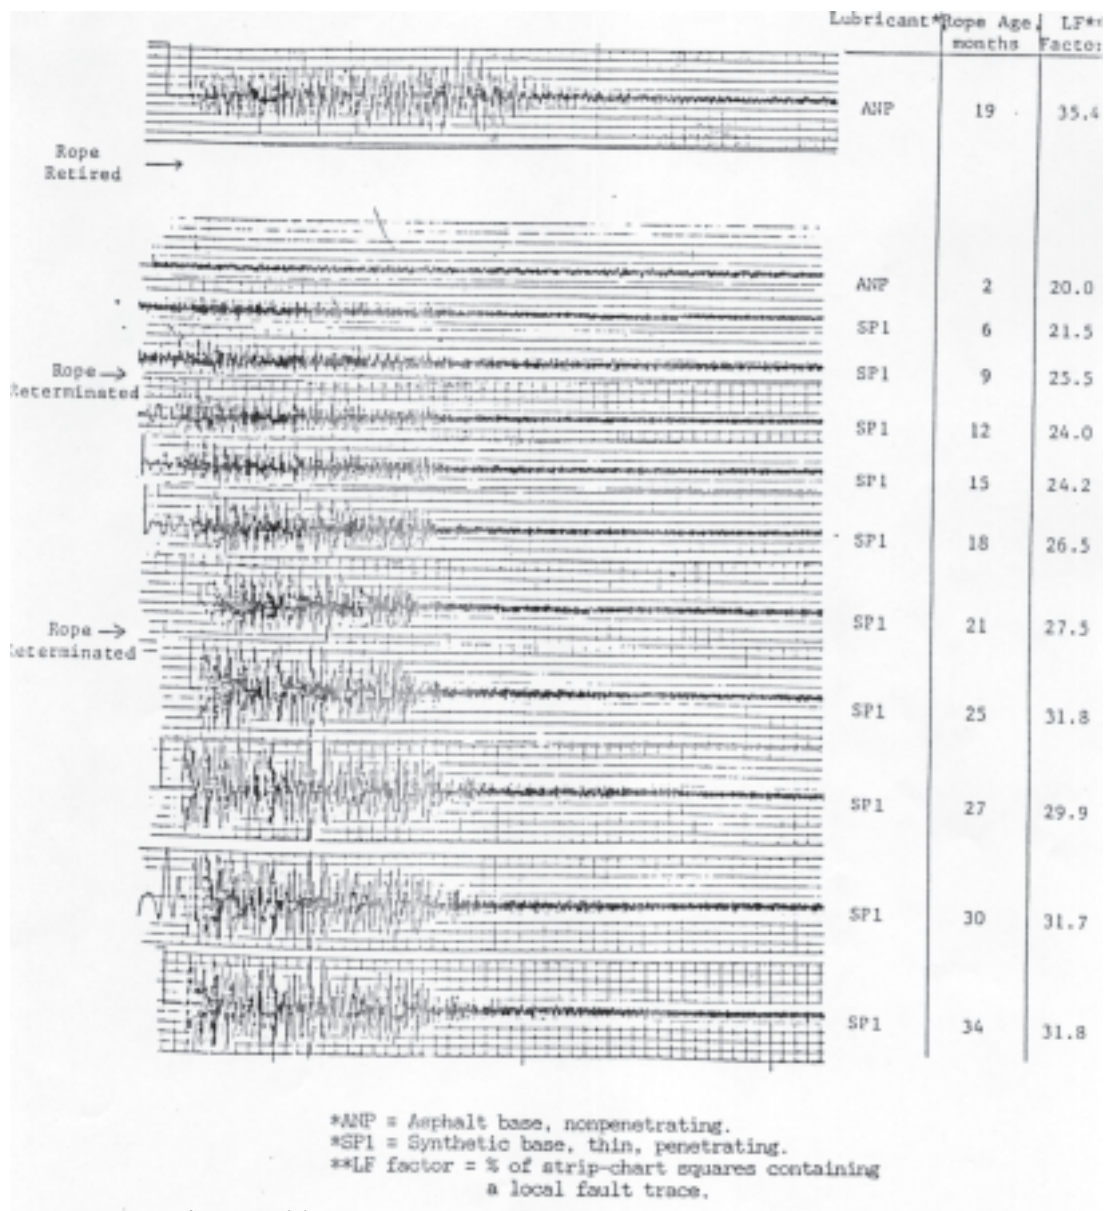
Figure 11 - LF strip charts for mine 1 north waste hoist ropes.
